EVALUATION OF CHLORIDE THRESHOLD FOR STEEL FIBER REINFORCED
CONCRETE COMPOSITES IN AGGRESSIVELY CORROSIVE ENVIRONMENTS

A Thesis Submitted to the Faculty of

Florida Atlantic University

May 2016

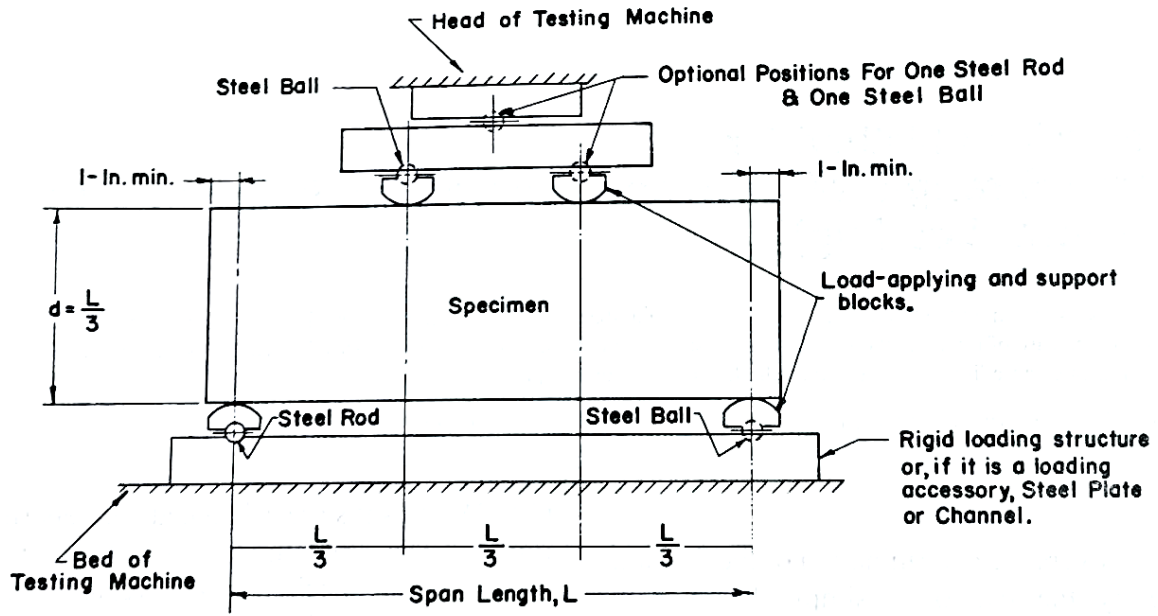
Figure 2.1 ASTM C78 test setup for beam bending [10]

examined these expectations. Beams were tested and compared using methods outlined in ASTM C78 after preliminary varying chloride (passive and accelerated) and oxygen exposure.

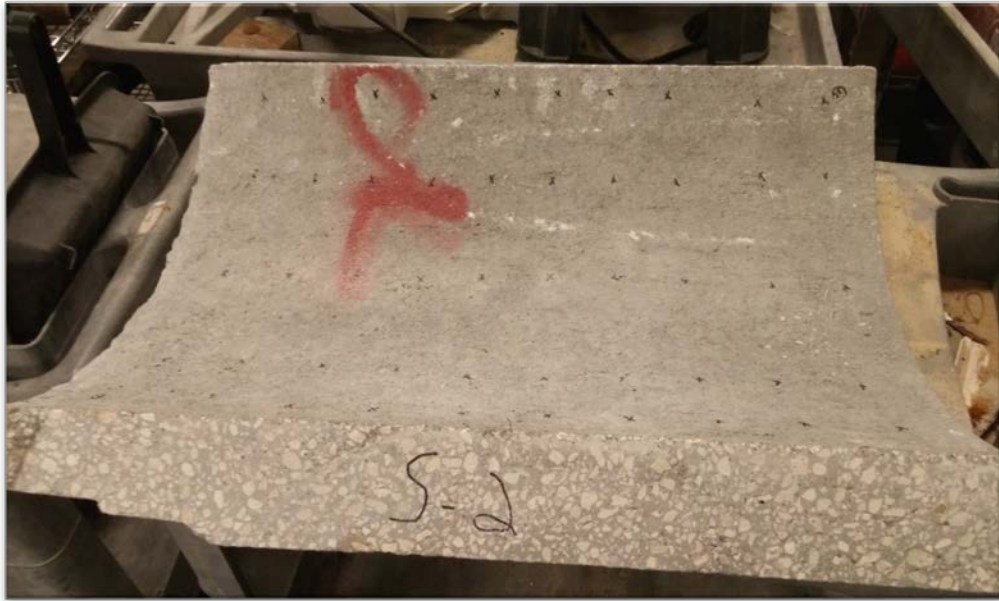
Figure 2.2 Pipe section S-2 made to be the no chloride control sample for beam bending
Photograph by Dietrich Vogel copyright 2016 by Dietrich Vogel

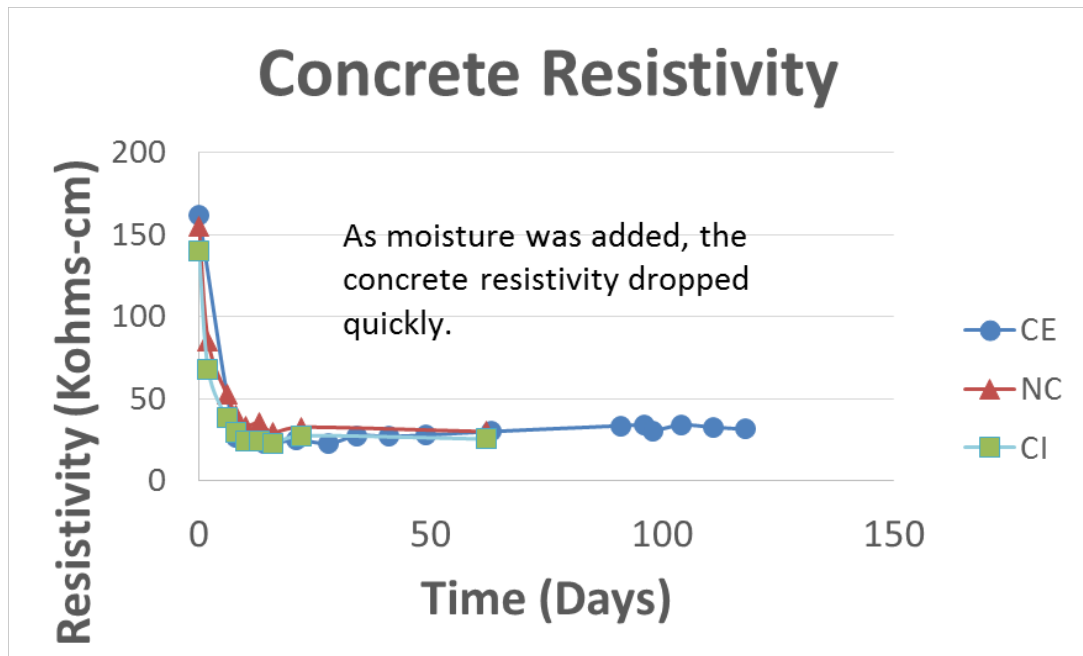
Figure 2.5 Graph of concrete resistivity over time in large pipe sections Photograph by Dietrich Vogel copyright 2016 by Dietrich Vogel

moistened the concrete. The moisture addition can be seen in the plot of the concrete resistivity over time. The plot (figure 2.5) was generated by averaging all resistivity measurements over the interior face for each sample. After the concrete was made moist, the resistivity values dropped and stabilized.

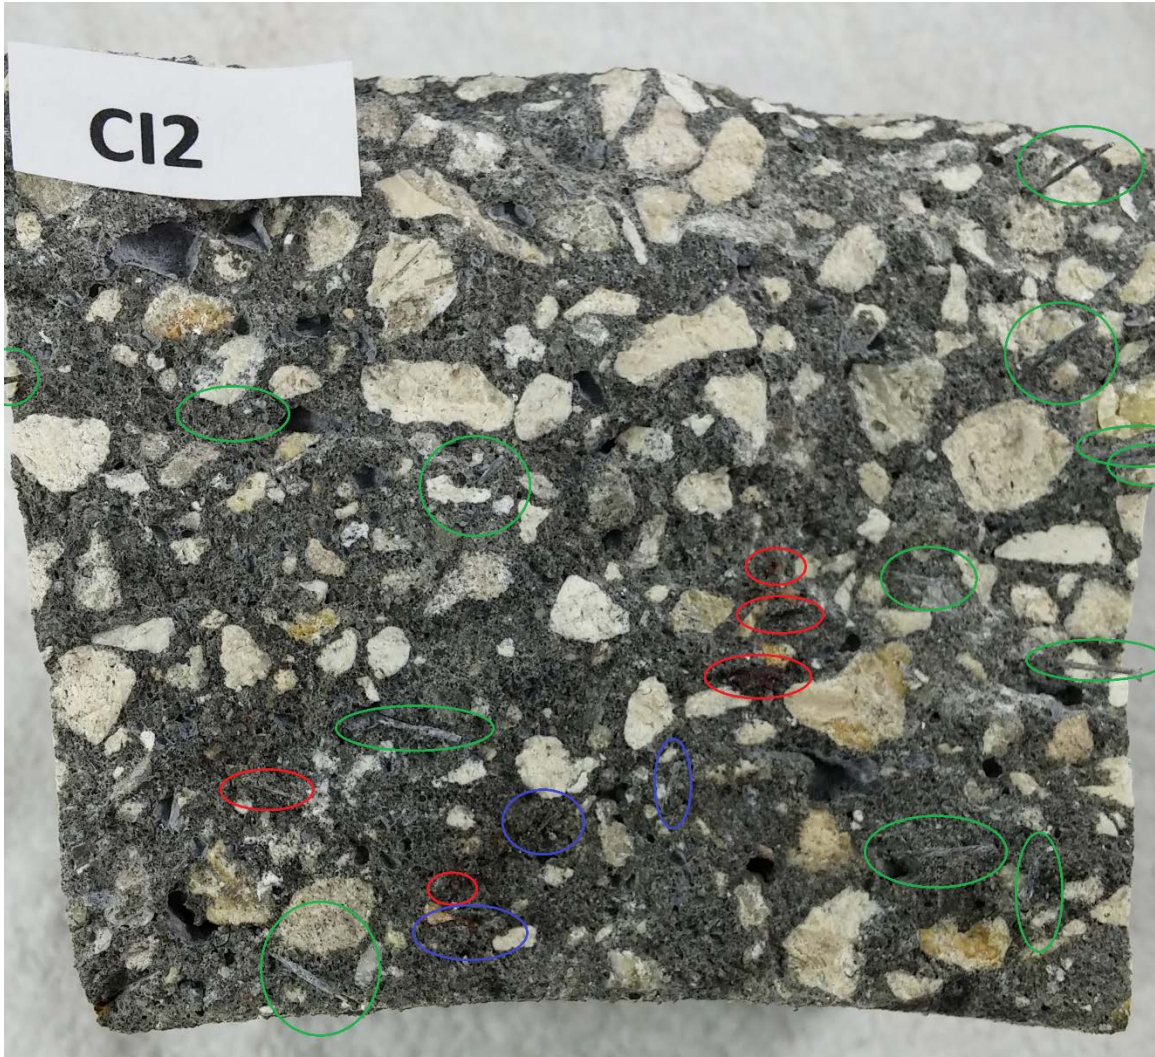
Figure 2.14 Beam sample CI2 with the fibers mapped and analyzed: 21 fibers, 5 brittle fractures and 3 corroded pullout fibers Photograph by Dietrich Vogel copyright 2016 by Dietrich Vogel

Chloride penetration was greatest in the CI beams and those samples tested the smallest flexural strength. Initial analysis shows that the chlorides have adversely affected the flexural strength of the concrete. Next, further analysis needs to be conducted on the beams to determine the method of failure and the degree of fiber degradation. Careful examination of beam failure planes determined the method of failure for each fiber. As mentioned in the experimental procedure section; fractures are either brittle (red circles), clean pullout (green circles), and pullout fibers with the onset of corrosion (blue circles) as depicted in figure 2.14 for beam CI2.

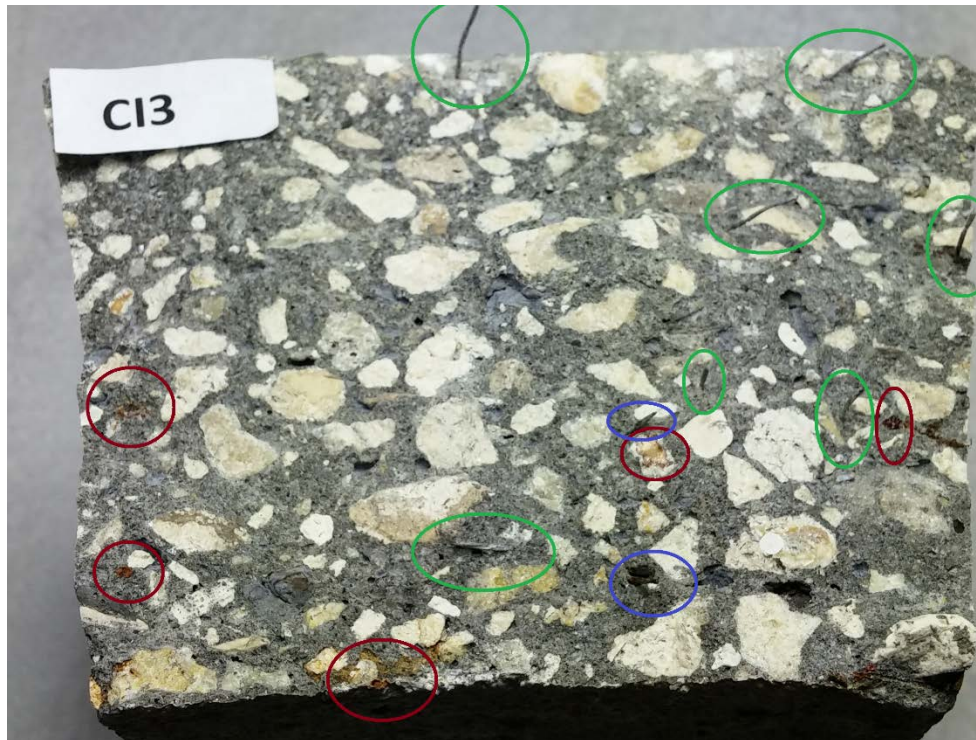
Figure 2.17 Beam sample CI3 with fibers mapped and the conditions analyzed
Photograph by Dietrich Vogel copyright 2016 by Dietrich Vogel

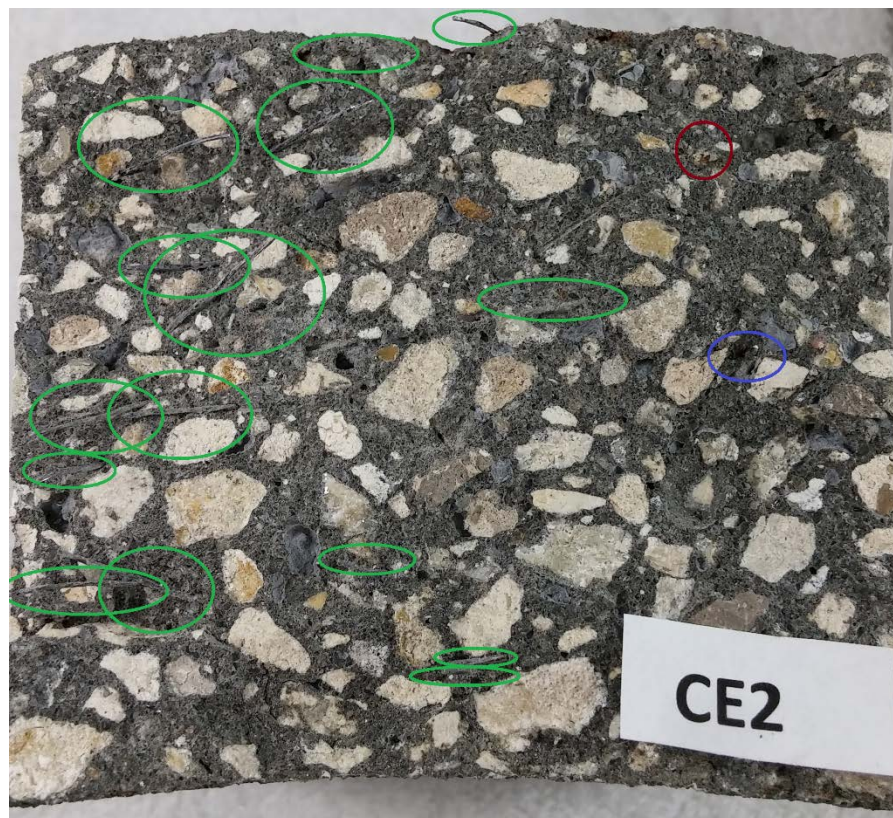
Figure 2.20 Beam sample CE3 with the fibers mapped and the conditions indicated by color Photograph by Dietrich Vogel copyright 2016 by Dietrich Vogel

Even though chloride transport was accelerated from the exterior and passively introduced from the interior, the CE beams showed very little chloride influence and minimal corrosion of fibers. The chloride penetration in sample CE was measured to be much less than the CI beams. Chloride penetration is highly dependent on concrete resistivity; since beams pipe section CE was dried out before chloride migration the resistivity had increased. Fibers in CE beams were exposed to less chlorides and less moisture; two critical factors in determining the chloride threshold. During modified RMT chlorides and moisture moved through the CE section but they did not penetrate as far as the CI section.

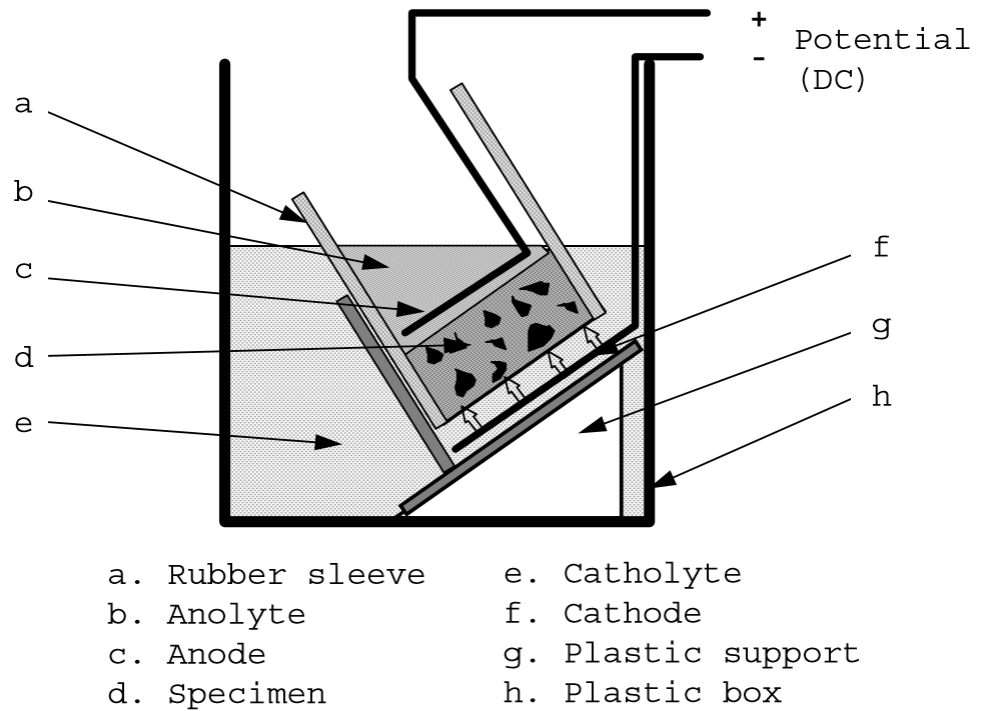
Figure 3.1 Single test setup for a chloride migration test indicated by NT build 492

Steel fiber reinforced drainage pipes are a new lower steel alternative to steel wire cage reinforced concrete pipes. Steel fiber reinforcement offers increased corrosion resistance to typical steel reinforced structures by having a more uniform micro-structure and a smaller volume to surface area ratio. Using a concrete testing standard (NT Build 492), chlorides can be migrated into concrete to initiate corrosion in the reinforcing steel fibers by applying an electric field that drives the chlorides via electro-migration.

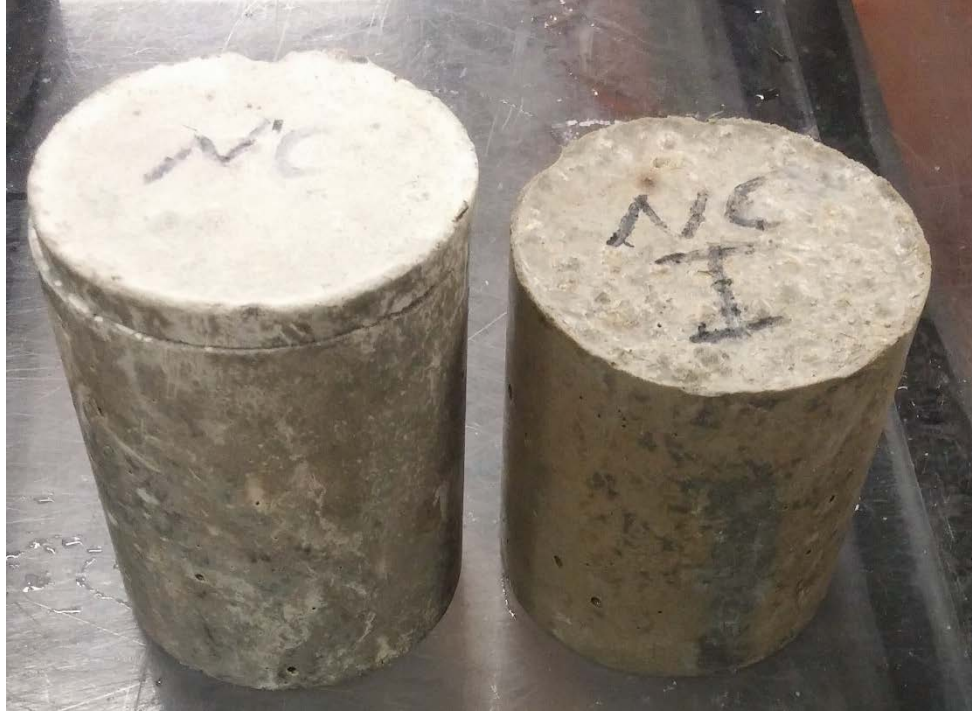
Figure 3.2 Non-instrumented samples cast without chlorides (NC, NCI) Photograph by Dietrich Vogel copyright 2016 by Dietrich Vogel

On 3/26, the no chloride samples NC and NC I were cast. Sample NCI contained iron flakes in the aggregate, and sample NC had the iron flakes removed before casting. Iron flakes in the aggregate was caused by poor aggregate storage conditions outdoors; particles from the roof have added impurities to the aggregate. The metal particles were cast in the NCI concrete sample. Careful examination has distinguished the steel fiber oxidation from the impure metal additives.

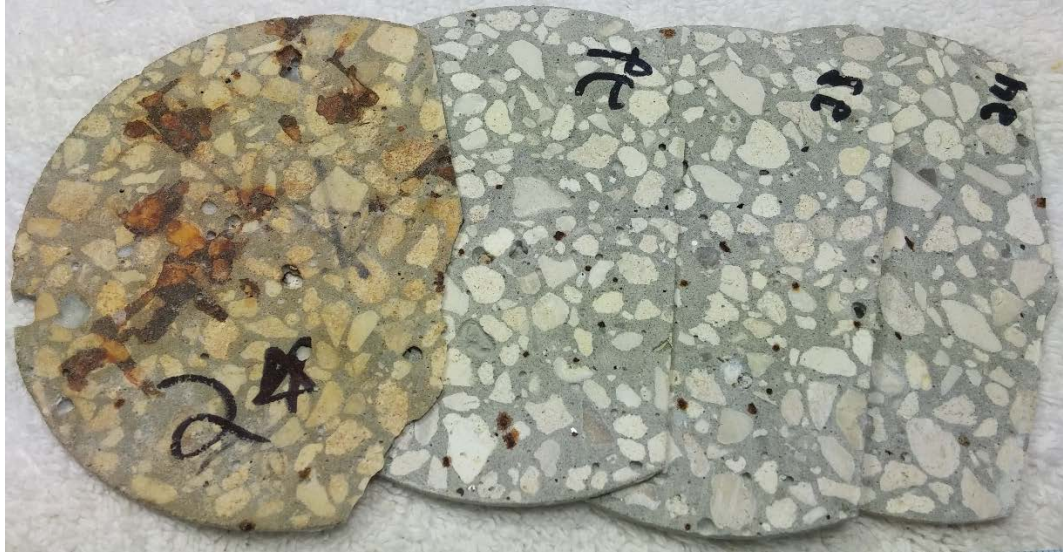
Figure 3.5 2mm slices taken from slice 2 of sample NCB after 4 weeks of lab humidity and oxygen exposure Photograph by Dietrich Vogel copyright 2016 by Dietrich Vogel

Samples B,C,2,3 were further analyzed for fiber condition and chloride concentration. Four slices approximately 2mm in thickness were taken from each cylinder.

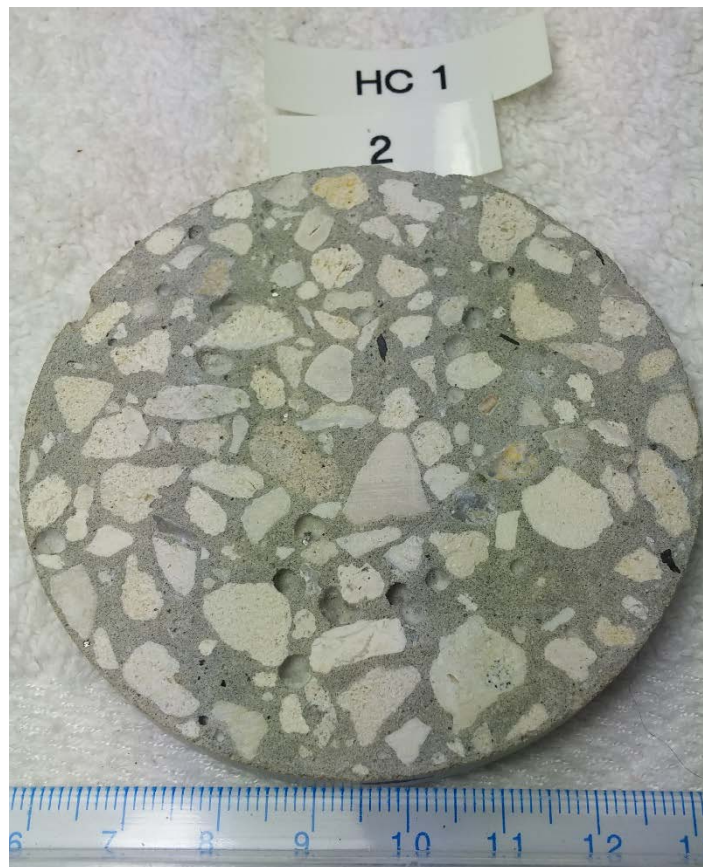
Figure 3.16 Disk HC1 exposed to inside conditions for 5 weeks Photograph by Dietrich Vogel copyright 2016 by Dietrich Vogel

was not high enough to stimulate oxidation of the steel fiber on slice HC1-2 seen in figure 3.16. The results from this experiment prove that the chloride threshold is a function of oxygen, moisture, and chloride presence; all three are required for steel fiber corrosion. To verify this result, the slices that were maintained in a plastic bag were analyzed. Pictures of the slices maintained at high humidity with limited oxygen exposure show fibers that remain mostly free of corrosion.

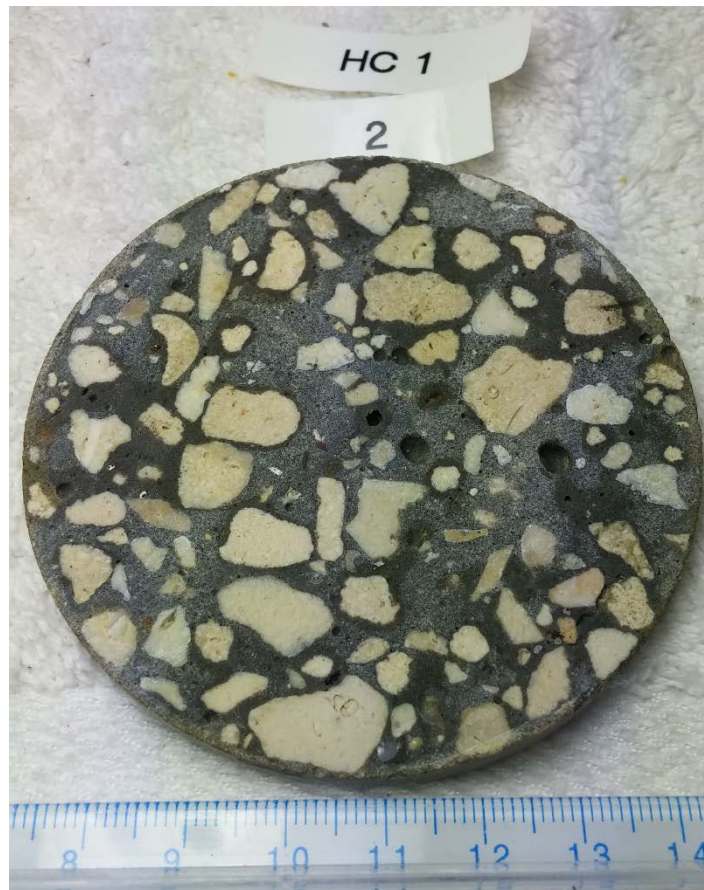
Figure 3.17 Disk HC1 Exposed to high humidity and restricted oxygen for 5 weeks
Photograph by Dietrich Vogel copyright 2016 by Dietrich Vogel

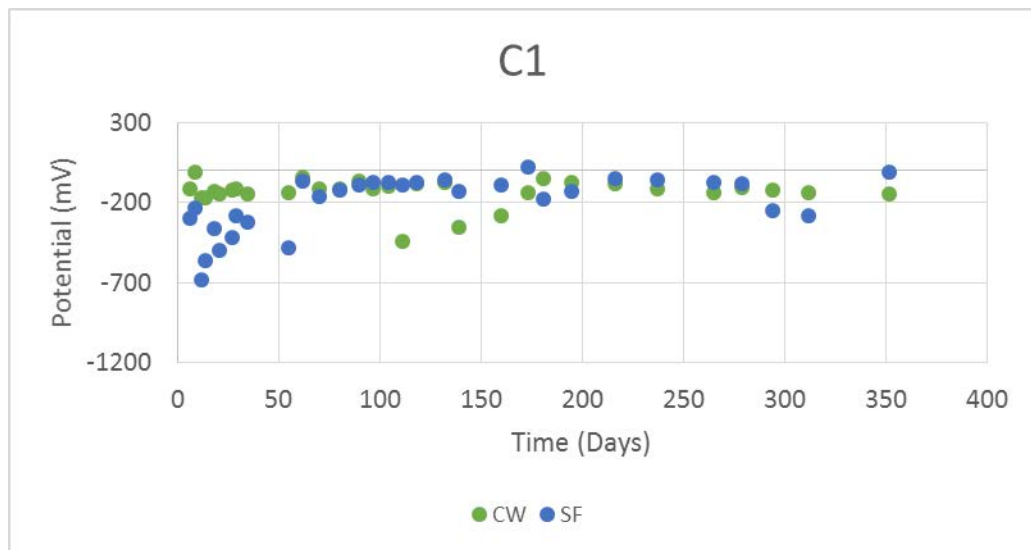
Figure 4.7 Corrosion potential graph of sample C1

Casting instrumented samples in concrete without chlorides has provided a base control measurement for the steel fibers. Fibers embedded in concrete without chlorides were expected to form a passive layer; protecting the steel from corrosion. The formation of a zinc oxide layer is seen in the figures 4.7, 4.8, and 4.9. Initial electrochemical activity was observed in the fibers while the zinc was oxidizing; once the oxide layer covered the zinc then the corrosion potentials became significantly more positive.

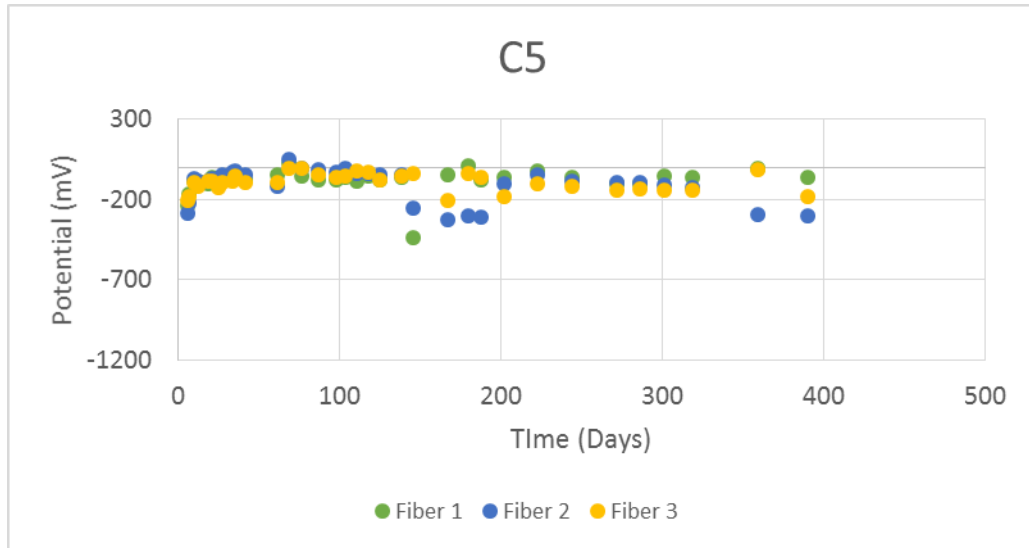
Figure 4.8 Corrosion potential graph of sample C5

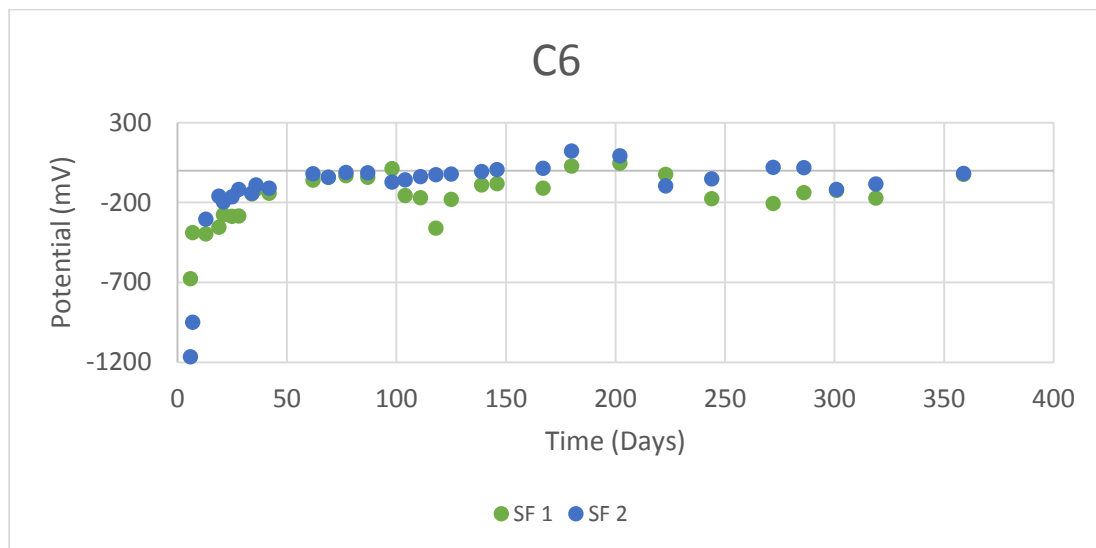
Figure 4.9 Corrosion potential graph of sample C6

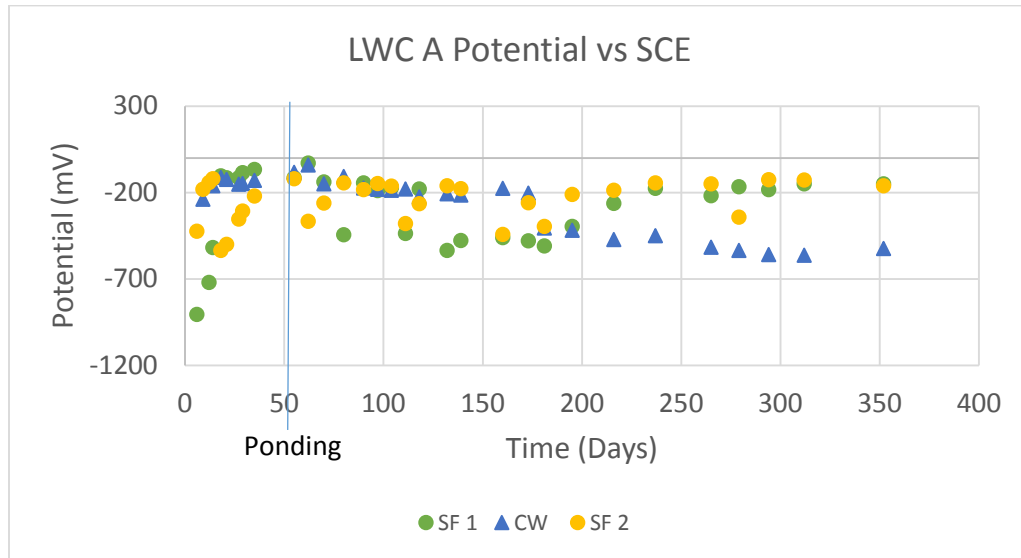
Figure 4.12 Corrosion potential graph of sample LWCA

The next sample type was also cast without chlorides. Chlorides were gradually introduced to samples LWCA, LWCB, and HWC after day 50 via the ponded reservoir. The corrosion potentials were measured over the course of a year and values were plotted for each fiber seen in figures 4.12, 4.13, and 4.14.

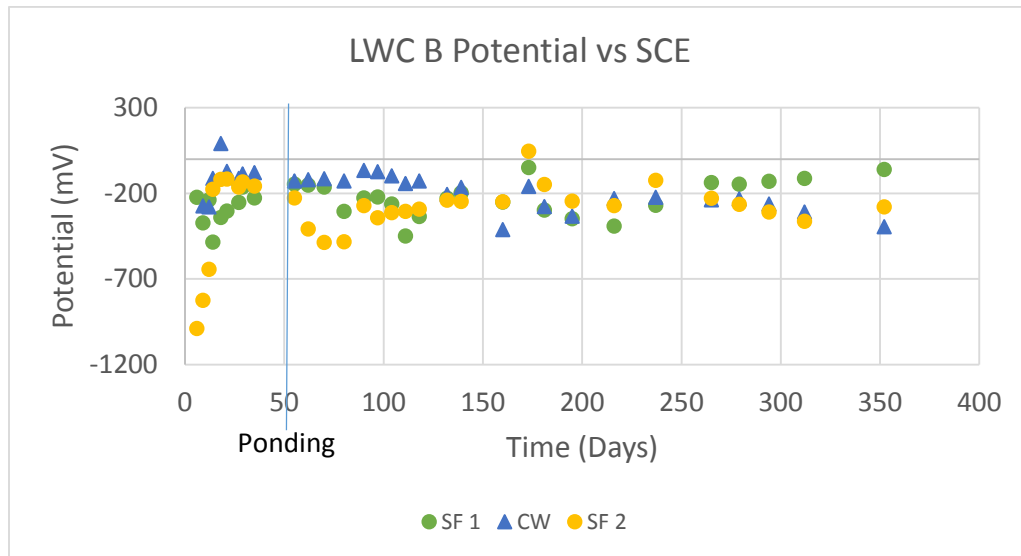
Figure 4.13 Corrosion potential graph of sample LWCB

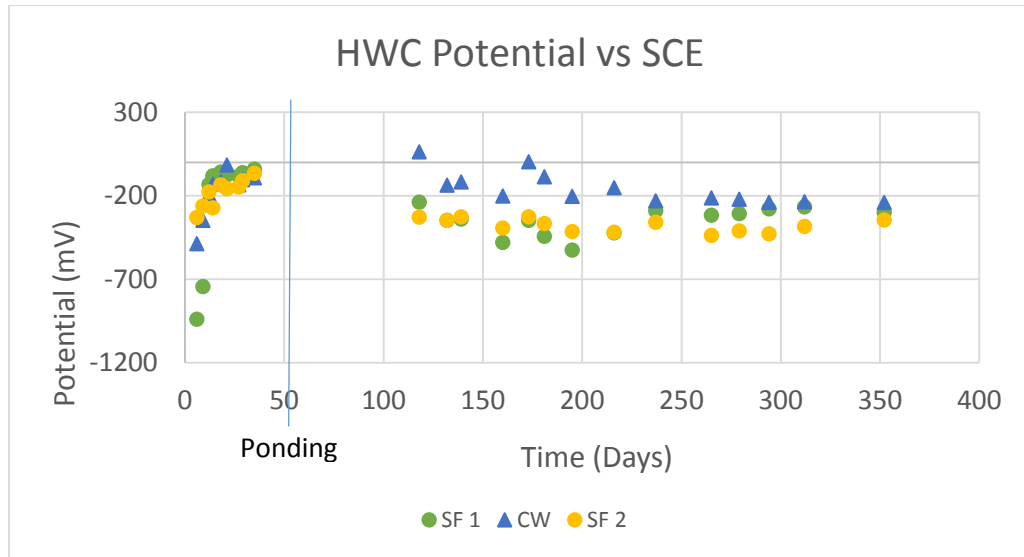
Figure 4.14 Corrosion potential graph of sample HWC

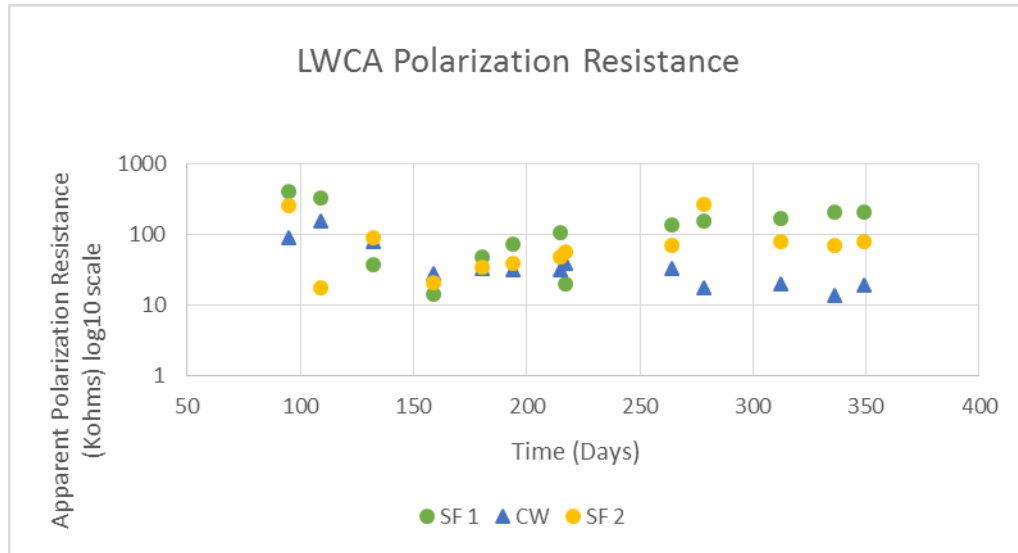
Figure 4.15 Apparent polarization resistance measurements graphed for sample LWCA

Corrosion potential measurements for the passive chloride migration samples initially mimicked the no chloride control samples. The steel fibers showed initial electrochemical activity in the zinc layer and then quick passivation of the fiber. Sometime after chlorides were introduced, slight dips were measured in some of the corrosion potentials indicating the presence of electrochemical activity. LPR measurements were plotted to gain a sense of the corrosion rate seen in figures 4.15, 4.16, and 4.17.

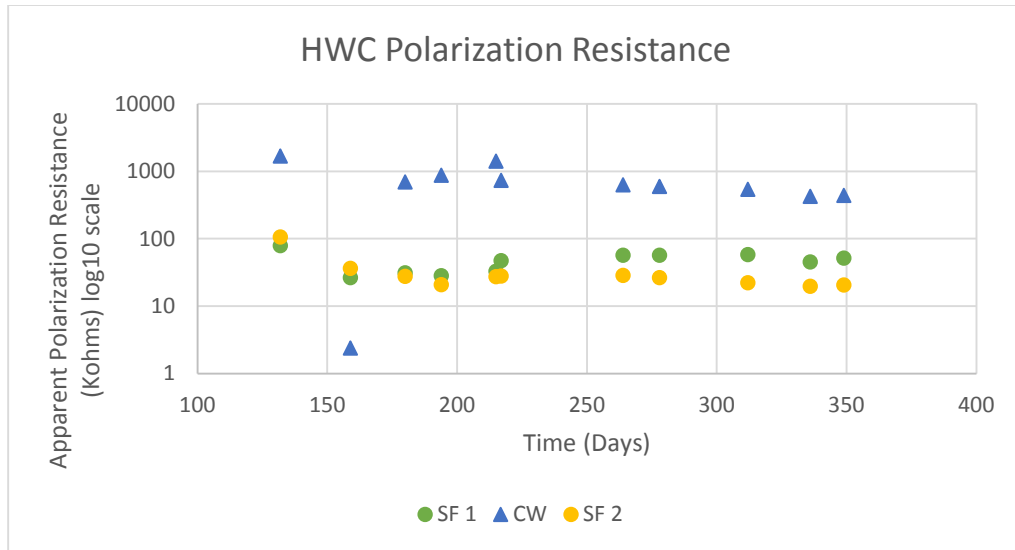
Figure 4.17 Apparent polarization resistance measurements graphed for sample HWC. For the samples LWCA, LWCB, and HWC LPR measurements revealed a very low corrosion rate. Analysis of the LPR measurements concluded that there would be very little or no corrosion found on the fibers during forensic analysis. For steel fibers of this size, an apparent polarization resistance less than 20Kohms is an indication of corrosion onset. Forensic analysis confirmed expectations; fibers were largely unaffected by corrosion initiated by the passive chloride migration.

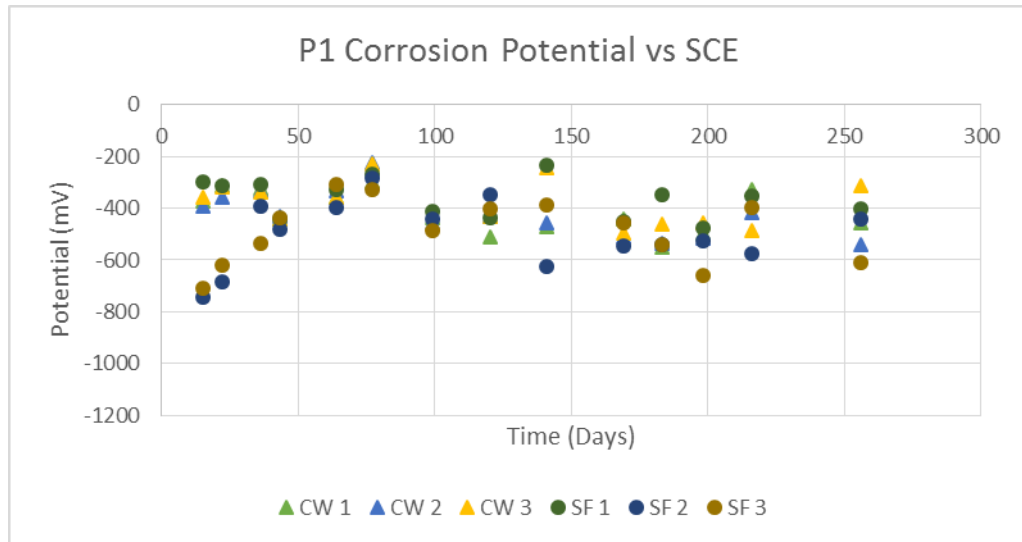
Figure 4.21 Corrosion potential for sample P1

While the instrumentation of the steel fibers has influenced the electrochemical activity in some fibers; the lack of instrumentation had a greater effect on the fiber surface conditions. Because the fibers were not instrumented, they were protruding from the concrete for measurement purposes. Very soon after the chloride pond was added to the concrete, the ends of the fibers oxidized and the measurements were impossible to make because the fibers would disappear. Spillage of the chloride solution in the reservoir likely reached the exposed fibers causing corrosion. While they were still protruding the corrosion potentials were measured and the values were graphed in figures 4.21 and 4.22.

The corrosion potential measurements detail the electrochemical activity in all the fibers poking out of the concrete. Every fiber had a corrosion potential below the ASTM corrosion line of -230 mV vs SCE. Even though the fibers were electrochemically active the LPR measurements suggested low corrosion rates as long as the fibers could be measured. Measurements from LPR tests are pictured in figures 4.23, and 4.24.

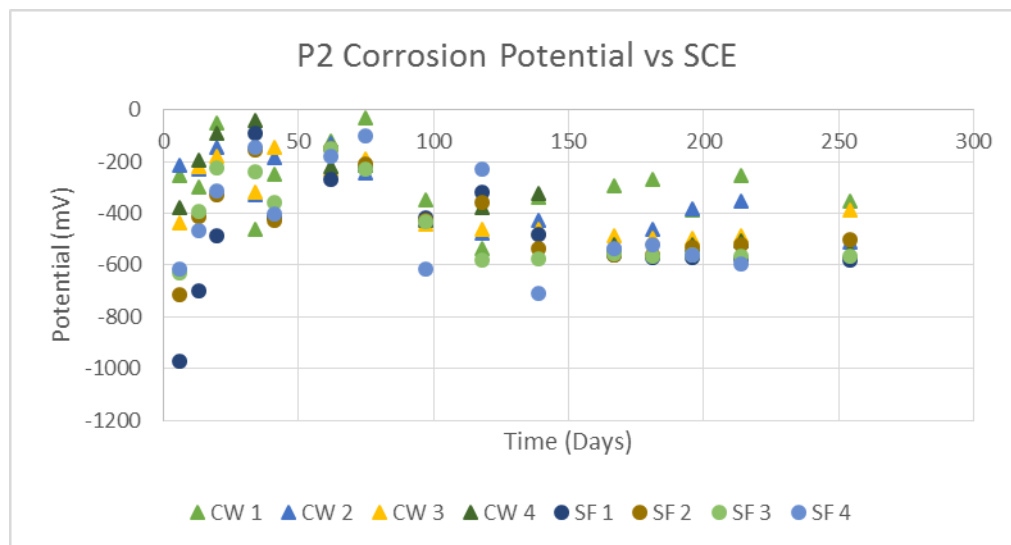
Figure 4.22 Corrosion potential for sample P2

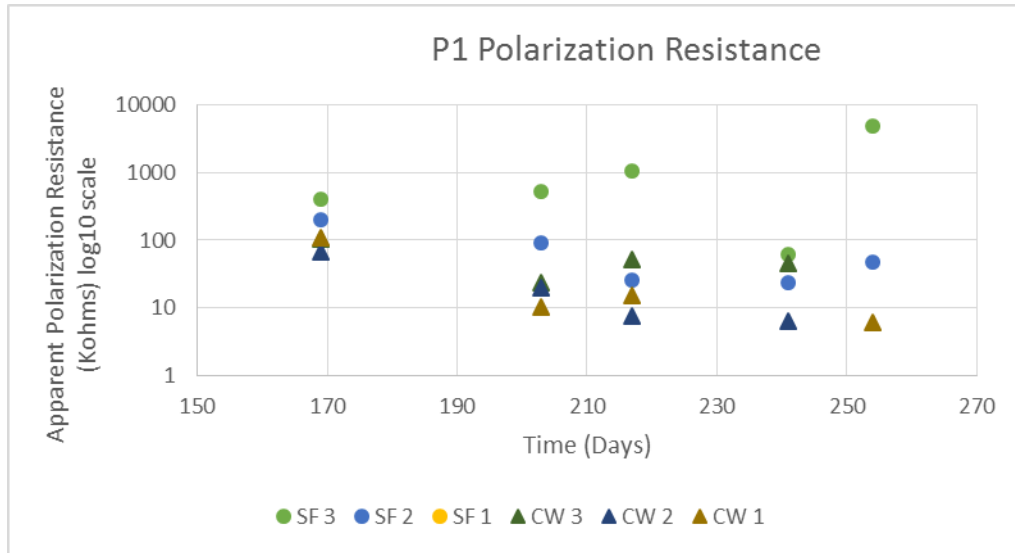
Figure 4.23 Apparent polarization resistance for sample P1

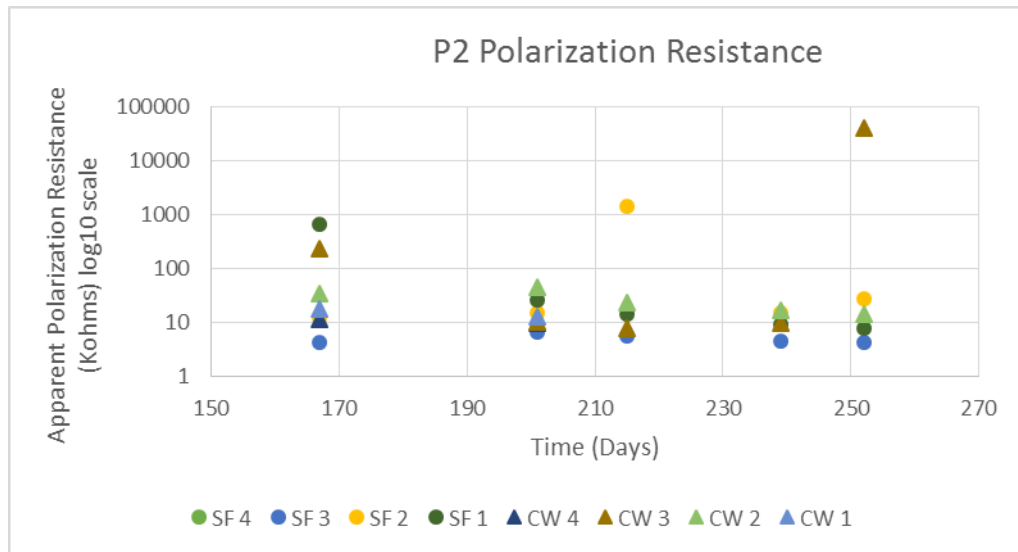
Figure 4.24 Apparent polarization resistance for sample P2

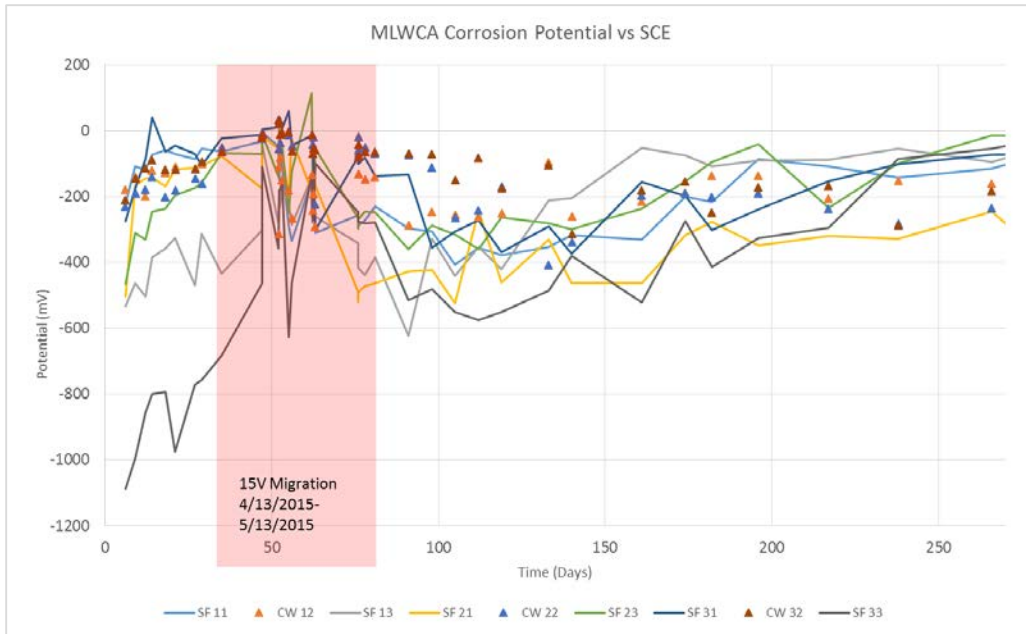
Figure 4.29 Corrosion potential for migration cylinder MLWCA

Two different attempts were made at modified rapid chloride migration through concrete with instrumented fibers; the first attempt involved cylinders MLWCA and MLWCB. The cylinders each contained 6 zinc electroplated steel fibers instrumented from both sides and 3 carbon steel wires instrumented from one side. The fibers were arranged in a 3x3 matrix pattern where the top row of three fibers were at 10mm cover depth and rows of fibers followed 10 and 20mm directly under. For forensic evaluation, the top 70mm was removed from the rest of the cylinder. A silver nitrate indicator confirmed chlorides to be in the concrete through 70mm cover distance. The corrosion potentials of each fiber was regularly monitored from both sides to ensure valid instrumentation. Corrosion potential measurements of the fibers in the migration cylinders are plotted in figures 4.29 and 4.30.

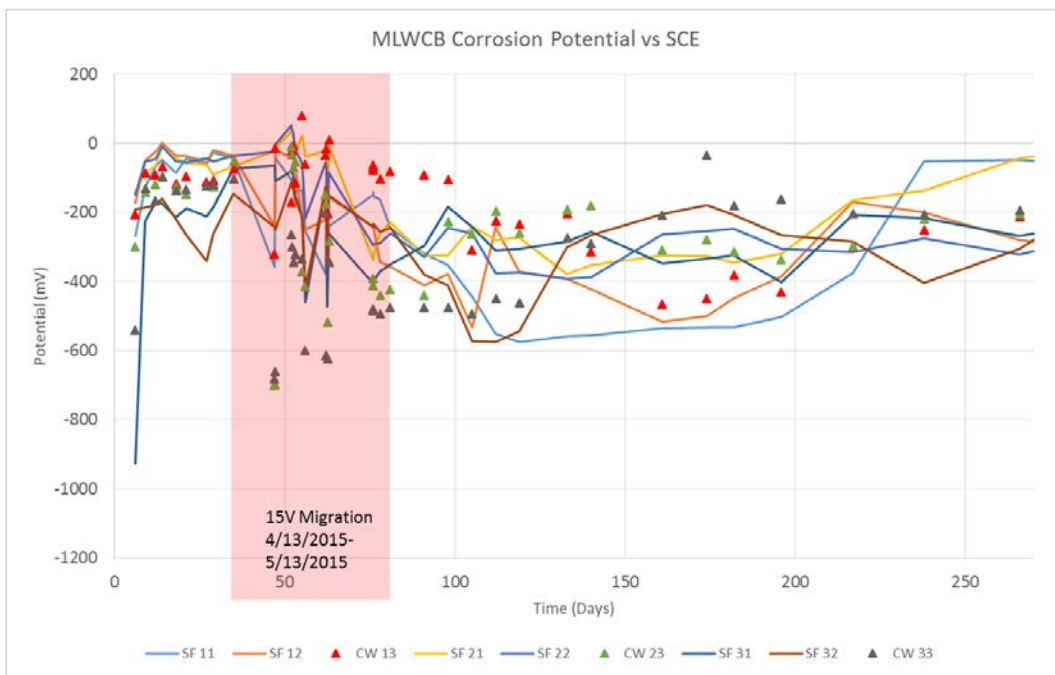
Figure 4.30 Corrosion potential for migration cylinder MLWCB

70mm cover distance the corrosion potentials of most fibers were above -200mv Vs SCE before the sample was terminated for analysis. The corrosion potentials indicated a lack of electrochemical activity.

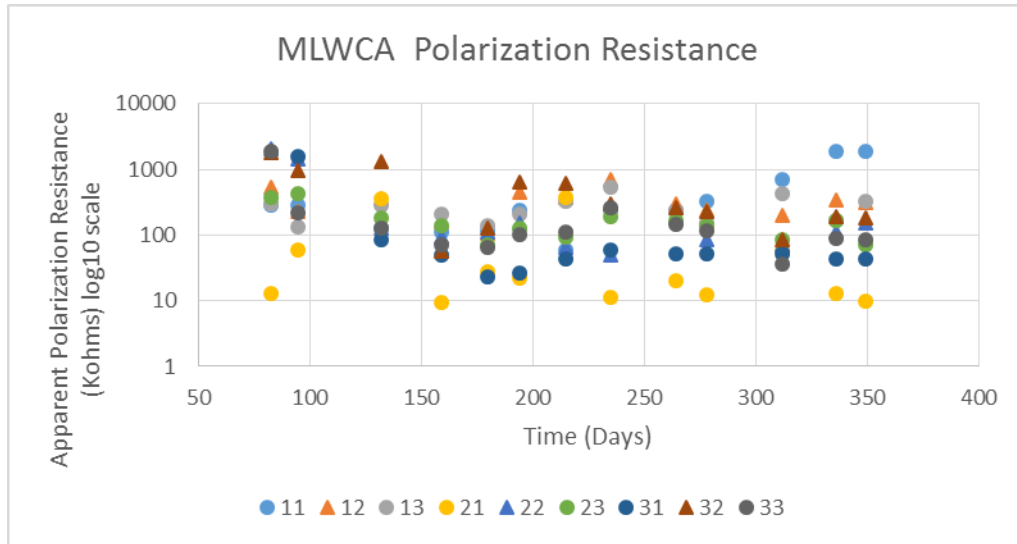
Figure 4.31 Polarization resistance for sample MLWCA

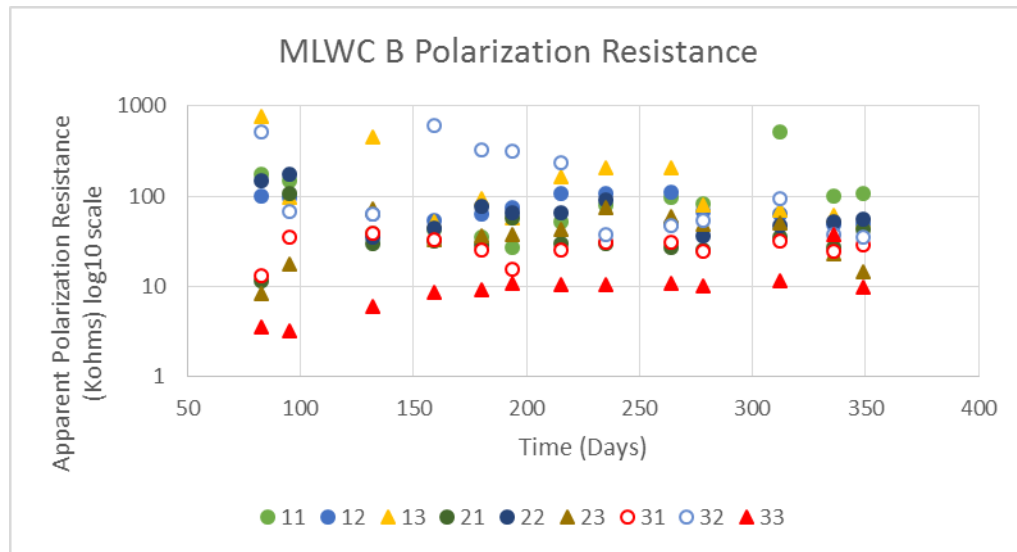
Figure 4.32 Polarization resistance for MLWCB

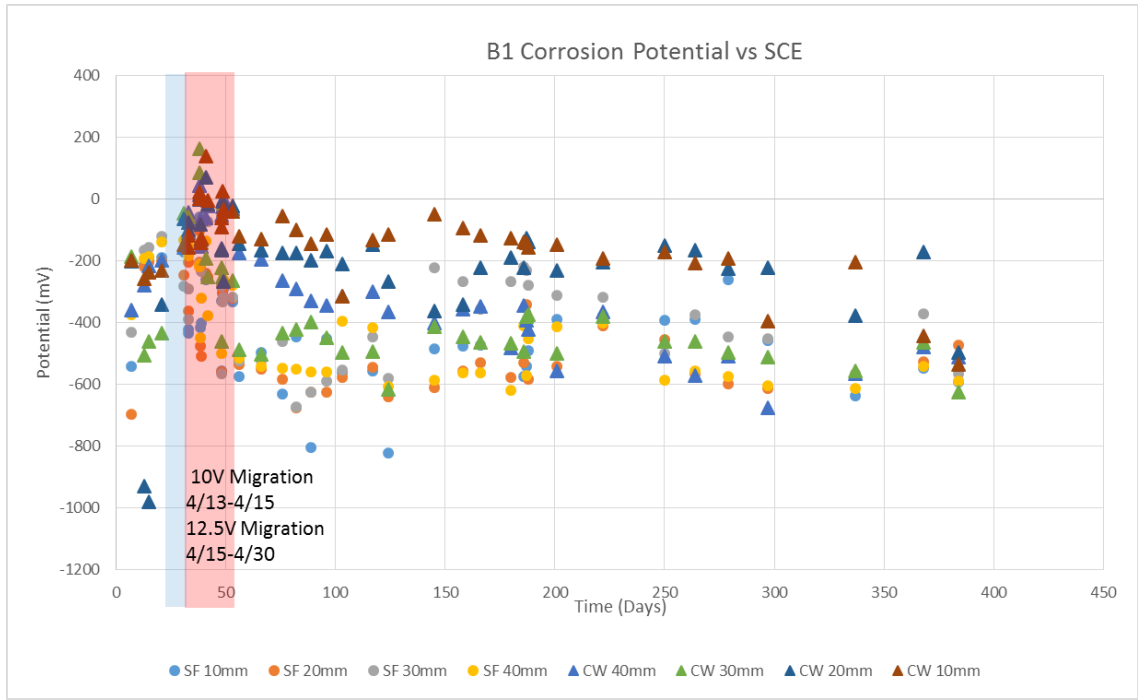
Figure 4.37 Corrosion potential for migration block B1

silver nitrate spray. Over the course of experimentation the blocks were measured for corrosion potential and the values are graphed in figures 4.37 and 4.38.

The corrosion potentials for all of the fibers indicate the presence of corrosion at the time of sample termination; the potentials were measured to be less than -230 vs. SCE. At the last set of measurements, the potentials of all fibers were below -400 vs SCE. Over time the fibers exhibited different behaviors from the migration cylinders. After the chloride migration, the corrosion potentials in the zinc electroplated steel fibers continued to decrease over time. The measurements of the apparent polarization resistance were examined to confirm the electrochemical activity measured with the corrosion potentials.

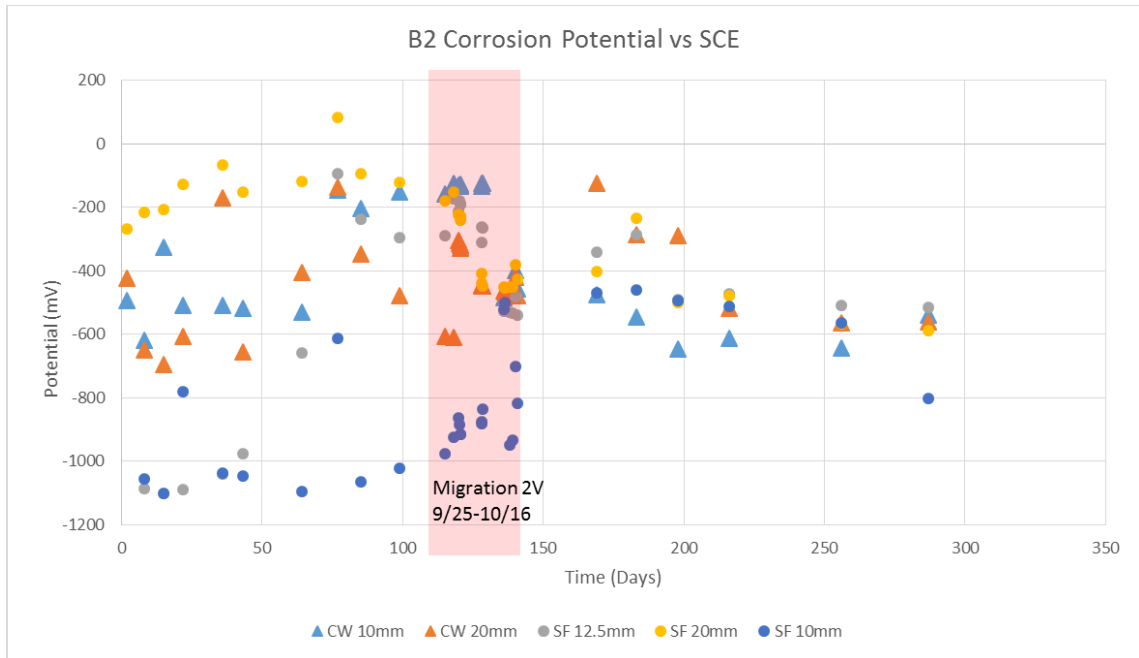
Figure 4.38 Corrosion potential for block B2

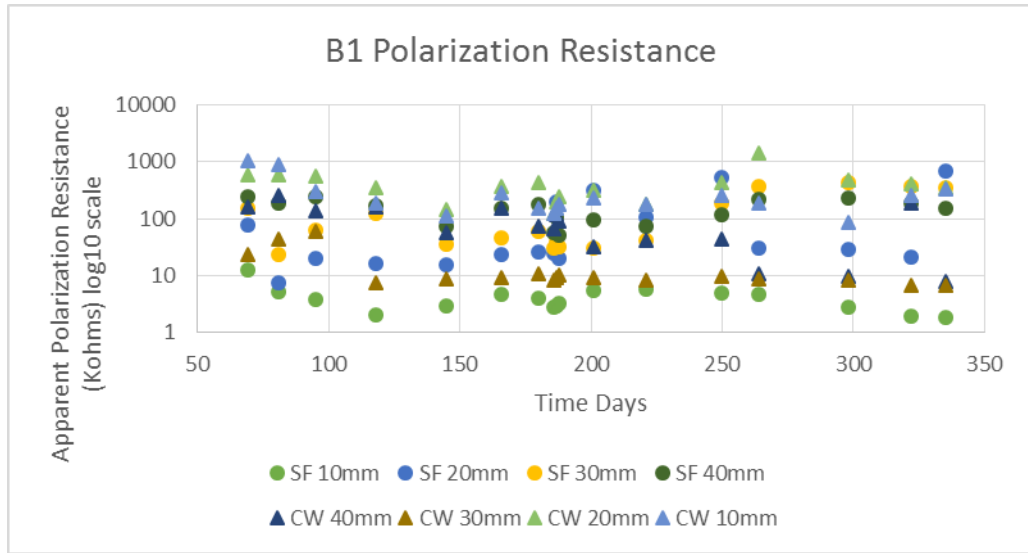
Figure 4.39 Polarization resistance for migration block B1

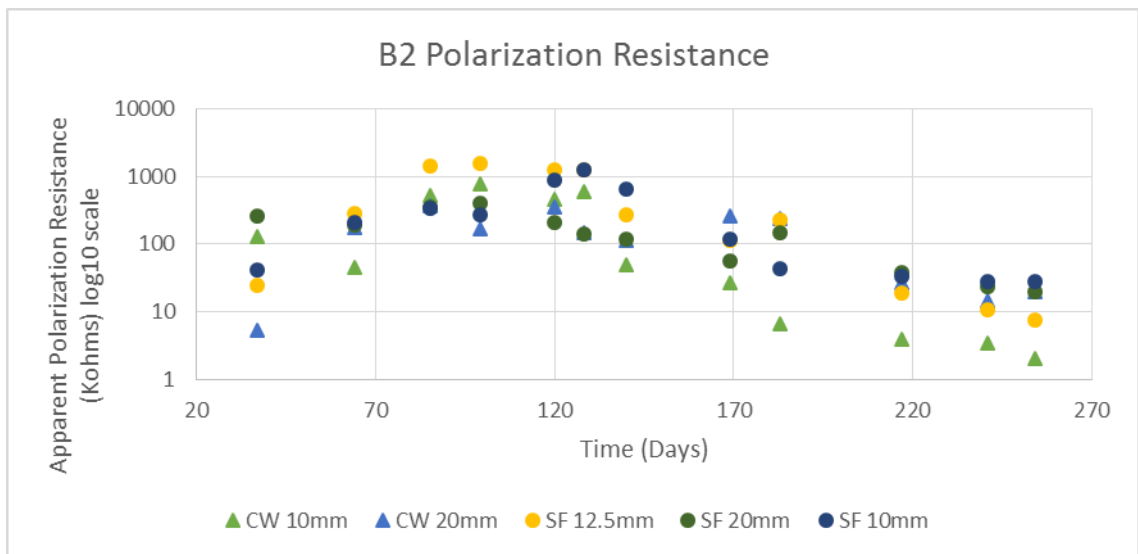
Figure 4.40 Polarization resistance for migration block B2
