EVALUATION OF CHLORIDE THRESHOLD FOR STEEL FIBER REINFORCED
CONCRETE COMPOSITES IN AGGRESSIVELY CORROSIVE ENVIRONMENTS

A Thesis Submitted to the Faculty of

Florida Atlantic University

May 2016

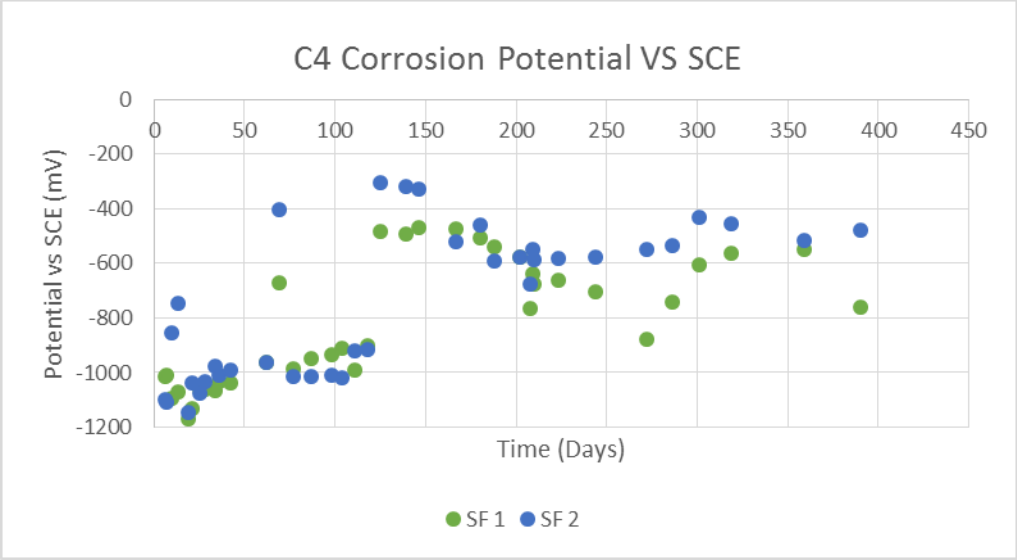
Figure 4.47 Corrosion potential of chloride cylinder C4

Concrete cylinders were cast with salt solution as the water used to mix the cementitious materials. Casting the samples with chlorides was a simple bypass for chloride deposition. Because the chlorides were already present in the concrete, the chloride threshold of each fiber only depended on the presence of oxygen and moisture. The corrosion potential measurements were an indication of electrochemical activity and their graphs are presented in figures 4.47, 4.48, and 4.49.

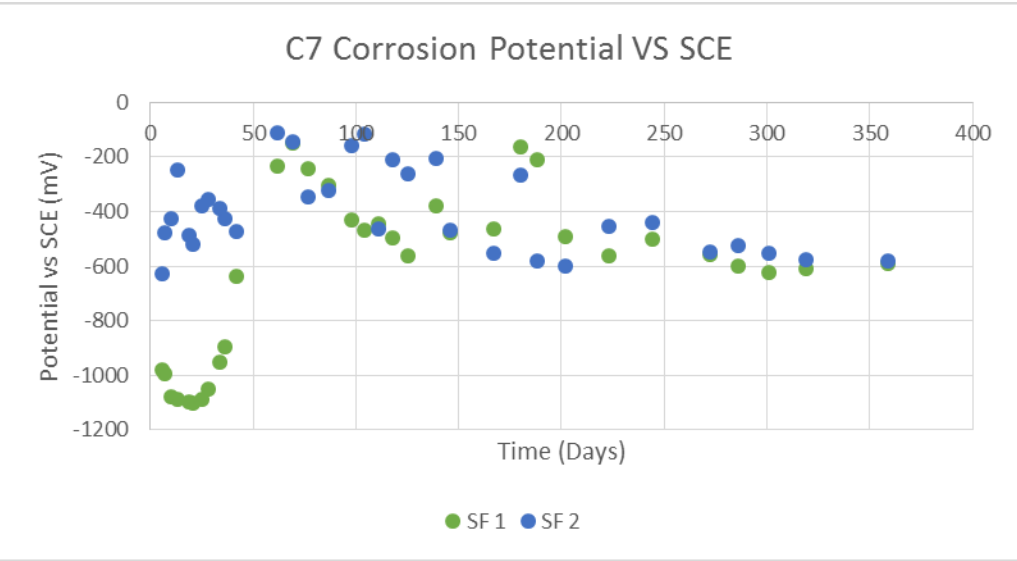
Figure 4.48 Corrosion potential of chloride cylinder C7

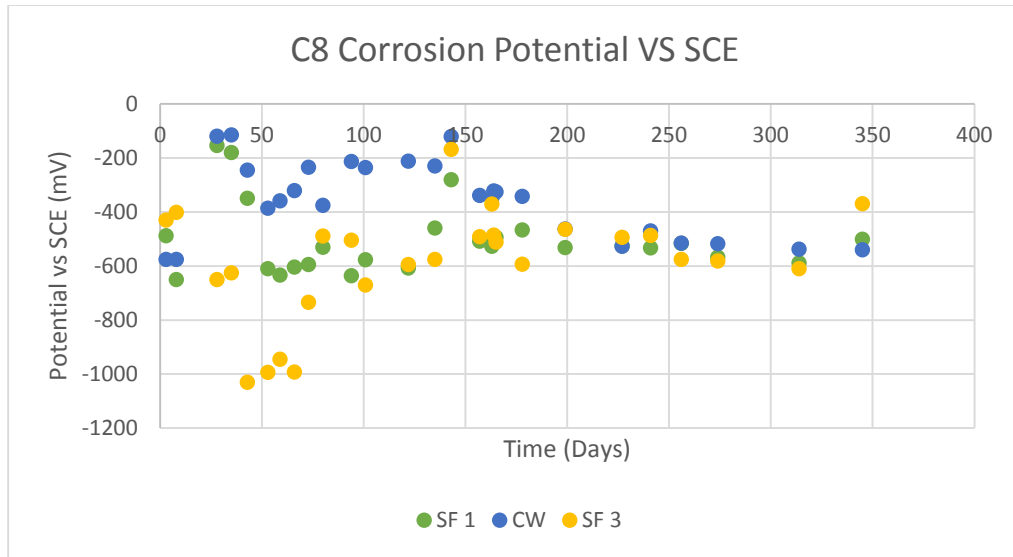
Figure 4.49 Corrosion potential of chloride cylinder C8

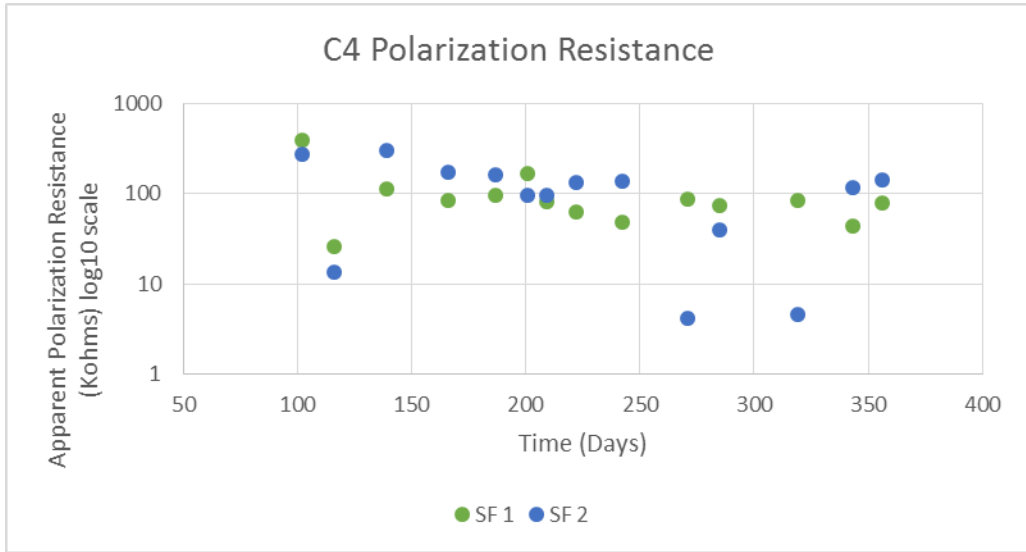
Figure 4.50 Apparent polarizations resistance for chloride cylinder C4

Steel fiber passivation was a slow and uncertain process in the samples cast with chlorides. The zinc electro coat was not able to form a passive layer around all of the steel fiber samples. Zinc was seen to be active at corrosion potentials below -1000mV; for sample C4 the zinc layer was active for over 100 days. Despite the thickness of the zinc electro coat, the chloride concentration was high enough to dissolve or not allow the zinc to form a protective oxide layer. Although the passive layer was being dissolved, the steel fiber corrosion rates were very small. LPR measurements confirmed the high polarization resistance for the steel fibers and their graphs are presented in figures 4.50, 4.51, and 4.52.

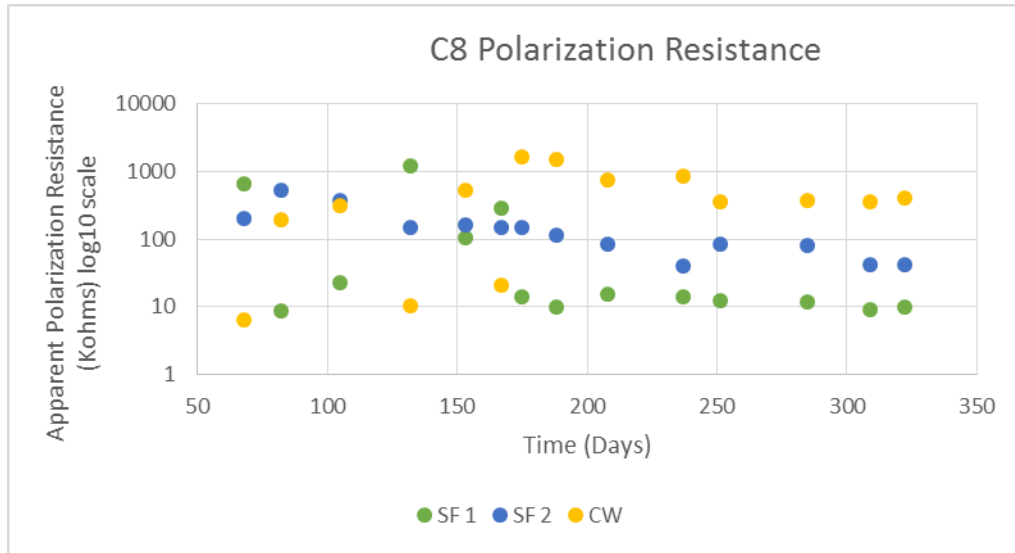
Figure 4.52 Apparent polarizations resistance for chloride cylinder C8

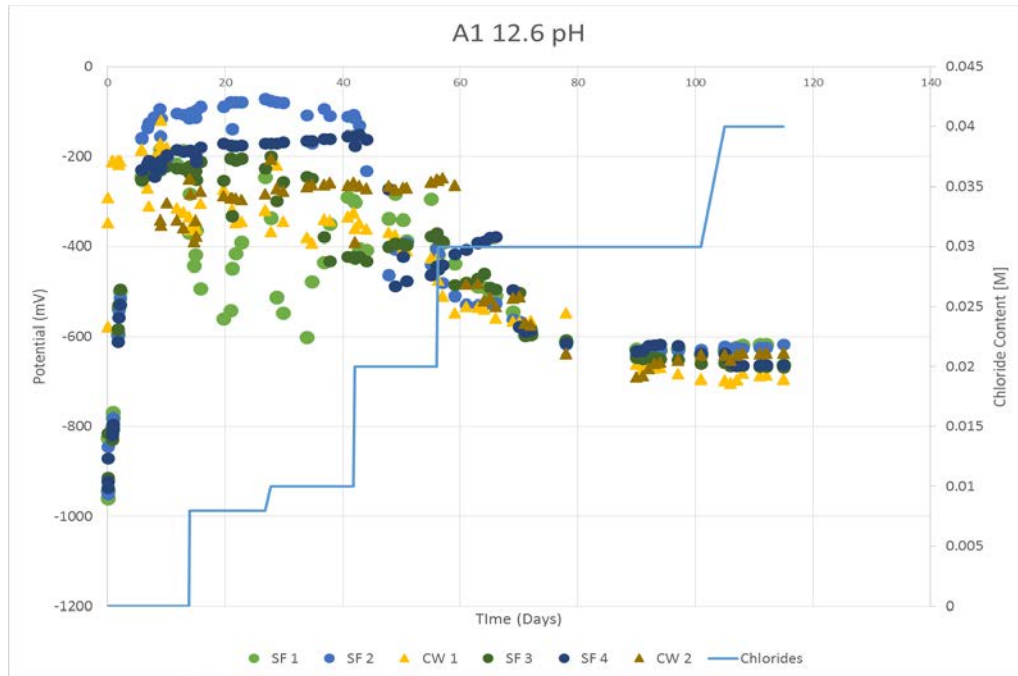
Figure 5.1 Corrosion potential for simulated pore solution A1

Instrumented fibers placed in simulated pore solution were regularly monitored for electrochemical activity. Because the chloride threshold depended on oxygen and moisture, corrosion could have initiated at any time between chloride additions. Corrosion potential measurements detailed the chloride additions and the sharp drop in fiber potential after the chloride threshold was reached.

At pH 12.6, the first fiber to indicate electrochemical activity was SF 1 after the first chloride addition of 0.008 moles per liter or 8 mmolar. It was not until the chloride concentration reached 20mmolar that the other steel fibers observed a drop in potential. In figure 5.1, the steel fibers were all shown to be electrochemically active when the chloride concentration passed 0.02 moles per liter. After the chloride threshold was surpassed, the fibers corrosion potential settled between -600 and -700mV.

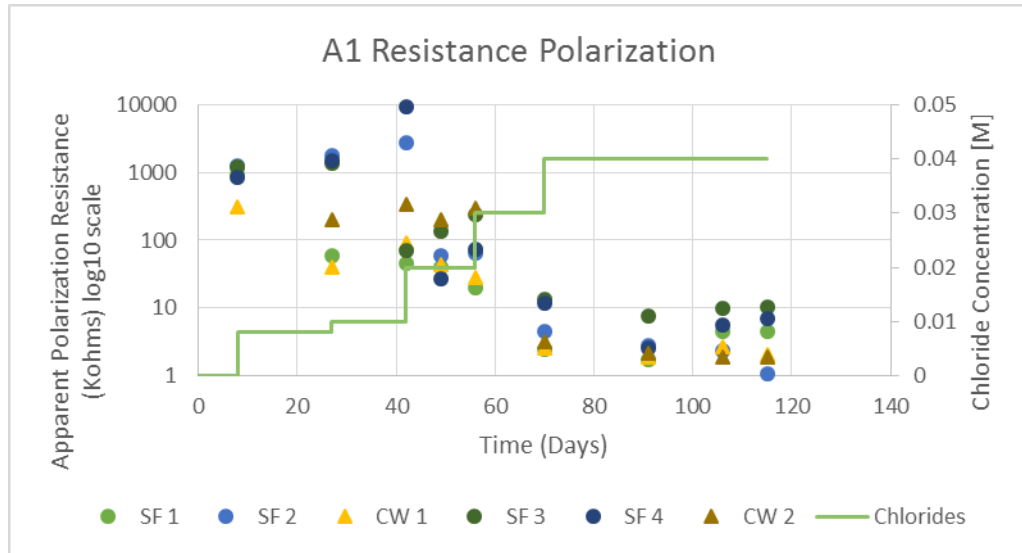
Figure 5.2 Apparent polarization resistance measurements for simulated pore solution sample A1

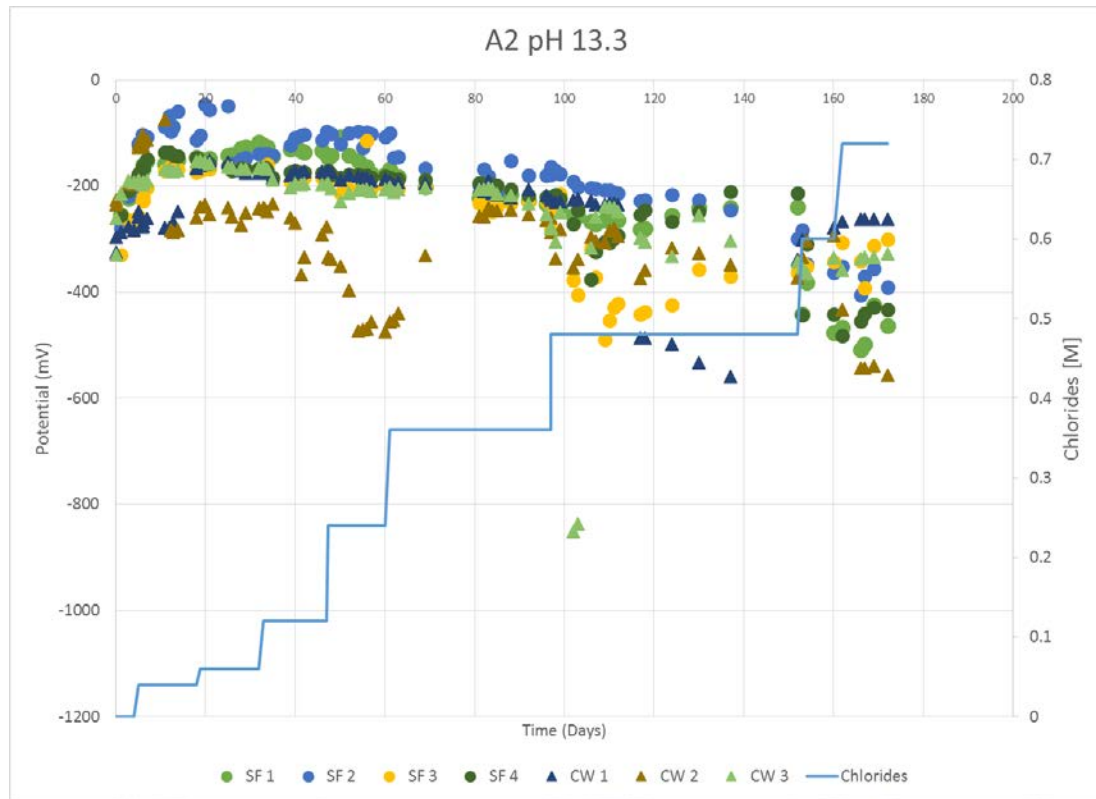
Figure 5.5 Corrosion potential for simulated pore solution A2

Soon after day 100 at a chloride concentration of 480mmolar, the first steel fiber was measured to have a corrosion potential dip; an indicator of corrosion. While one fiber (figure 5.5 SF 3) showed electrochemical activity other three steel fibers remained passive until day 160 where the fiber potentials begin to tail off and not drop suddenly.

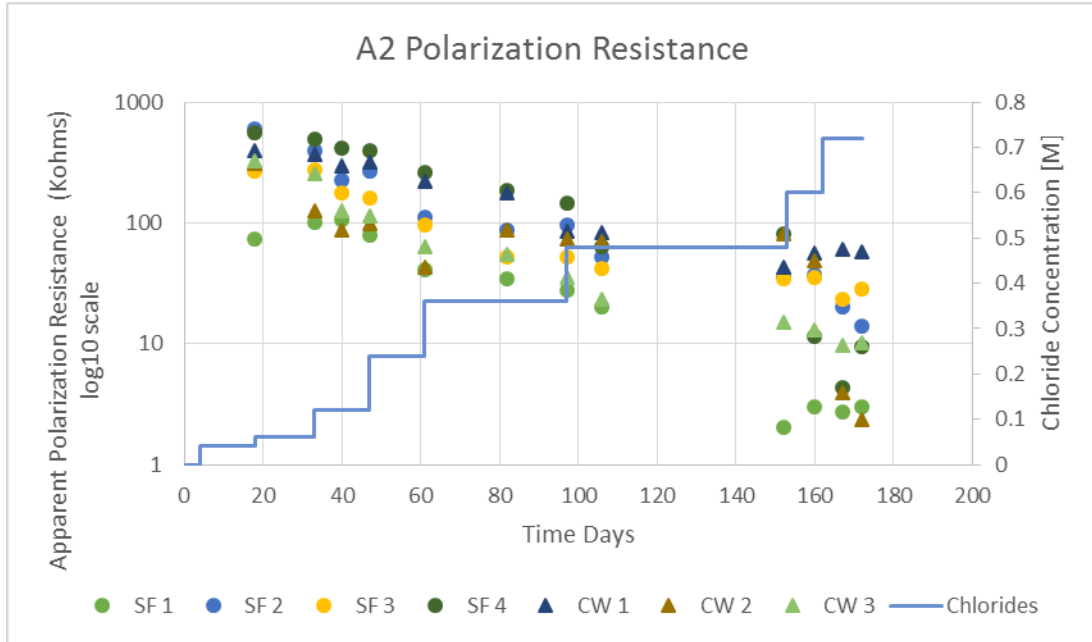
Figure 5.6 Apparent polarization resistance measurements for simulated pore solution sample A2

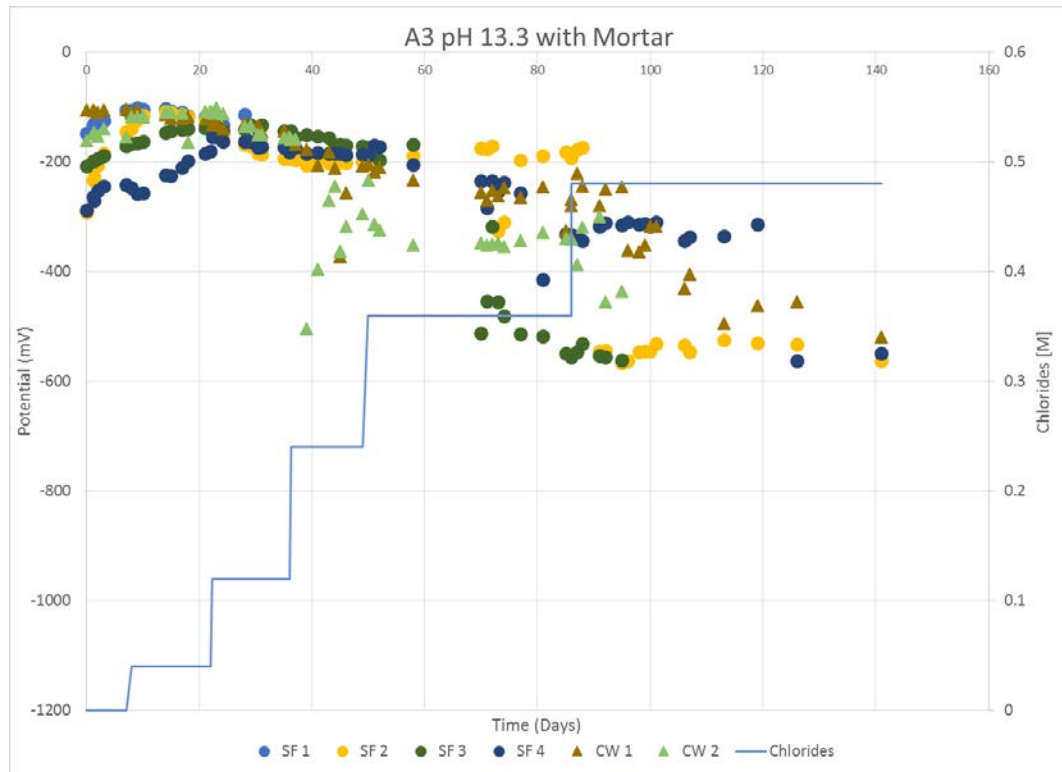
Figure 5.7 Corrosion potential for simulated pore solution A3

Corrosion potential measurements were grouped tightly until the chloride concentration reached 360mmolar. Figure 5.7 depicts the moment that the chlorides started to dissolve the passive layer. The transient began after the 240 mmolar chloride addition for one of the carbon steel wires. Just after day 60 three out of four steel fibers had a drop in potential. The fourth zinc electroplated steel fiber reached the chloride threshold after the 480mmolar chloride addition.

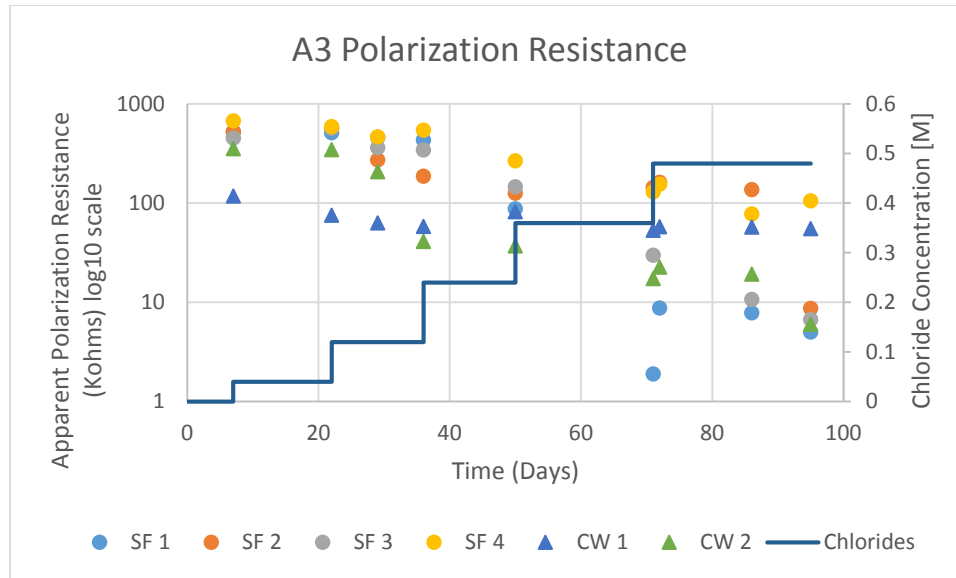
Figure 5.8 Apparent polarization resistance measurements for simulated pore solution sample A3

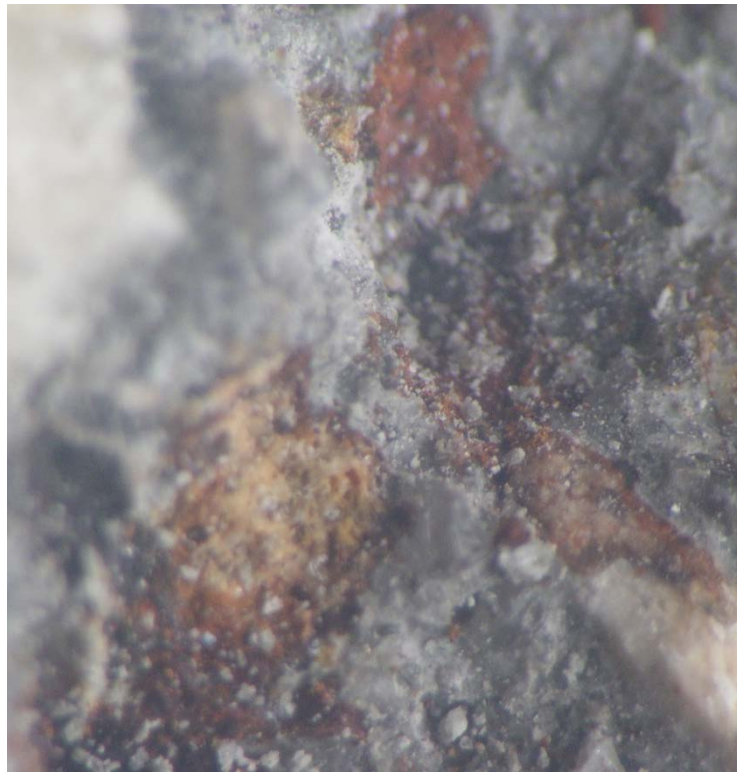
Figure 7.41 Microscope picture of a brittle fracture in beam sample CI2

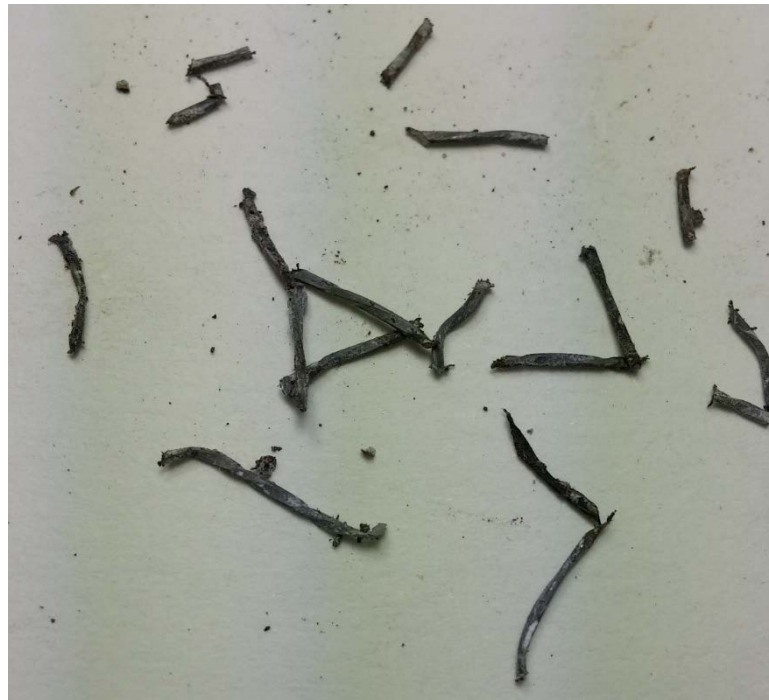
Figure 7.71 Fibers extracted from slice 8mm to 10mm cover depth RMT sample 3
